# **Making the Best of a Bad Situation: From leaking UST Over Fractured Bedrock with Closed Municipal Wells to Case Closure – A Success Story**

Warren Gross, P.G., C.E.G., C.H.G.

CRWQCB – Region 5, Fresno

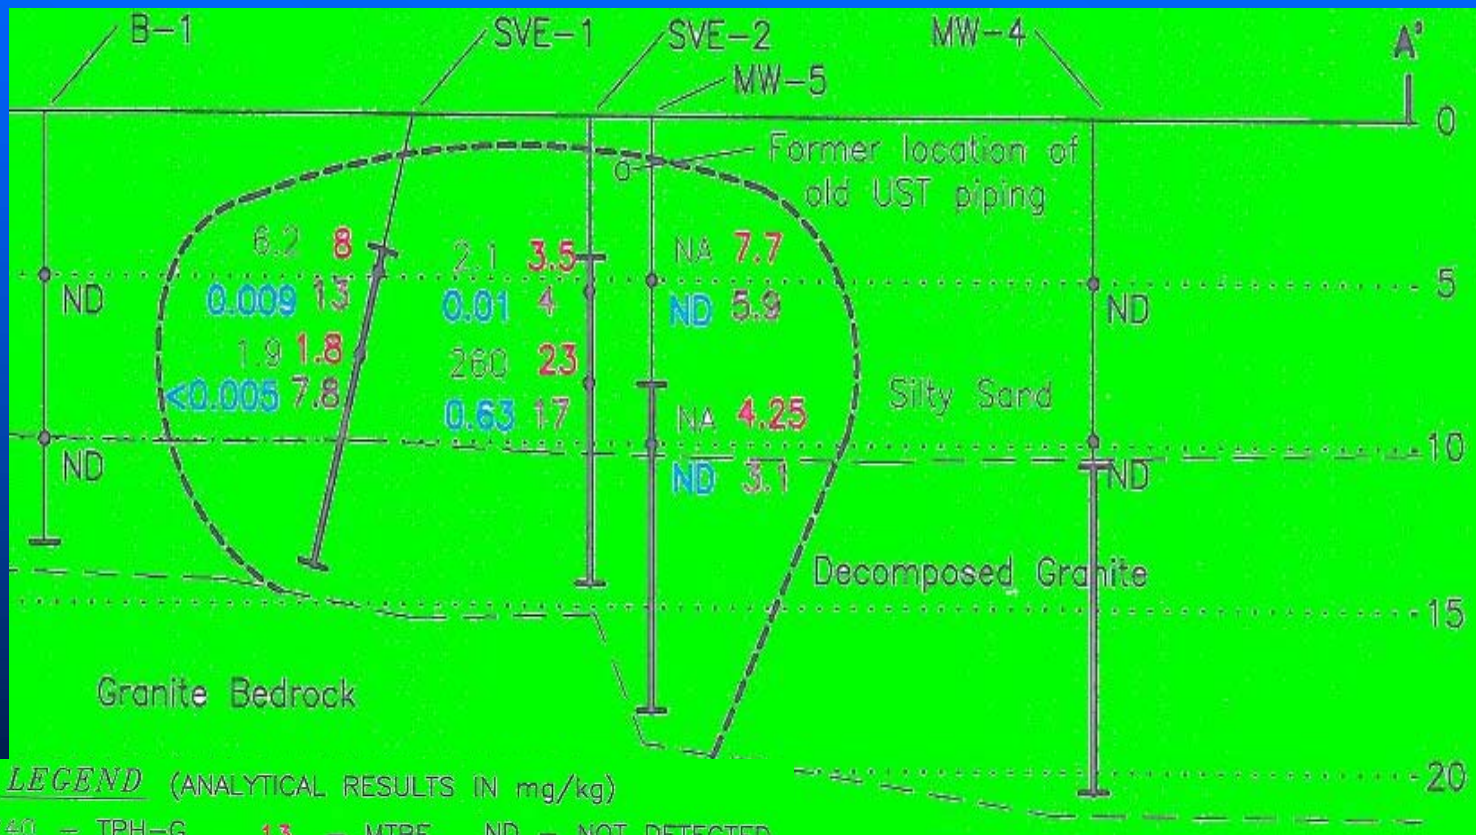
# Cross-Section A-A'

----- ESTIMATED EXTENT OF GASOLINE CONSTITUENTS

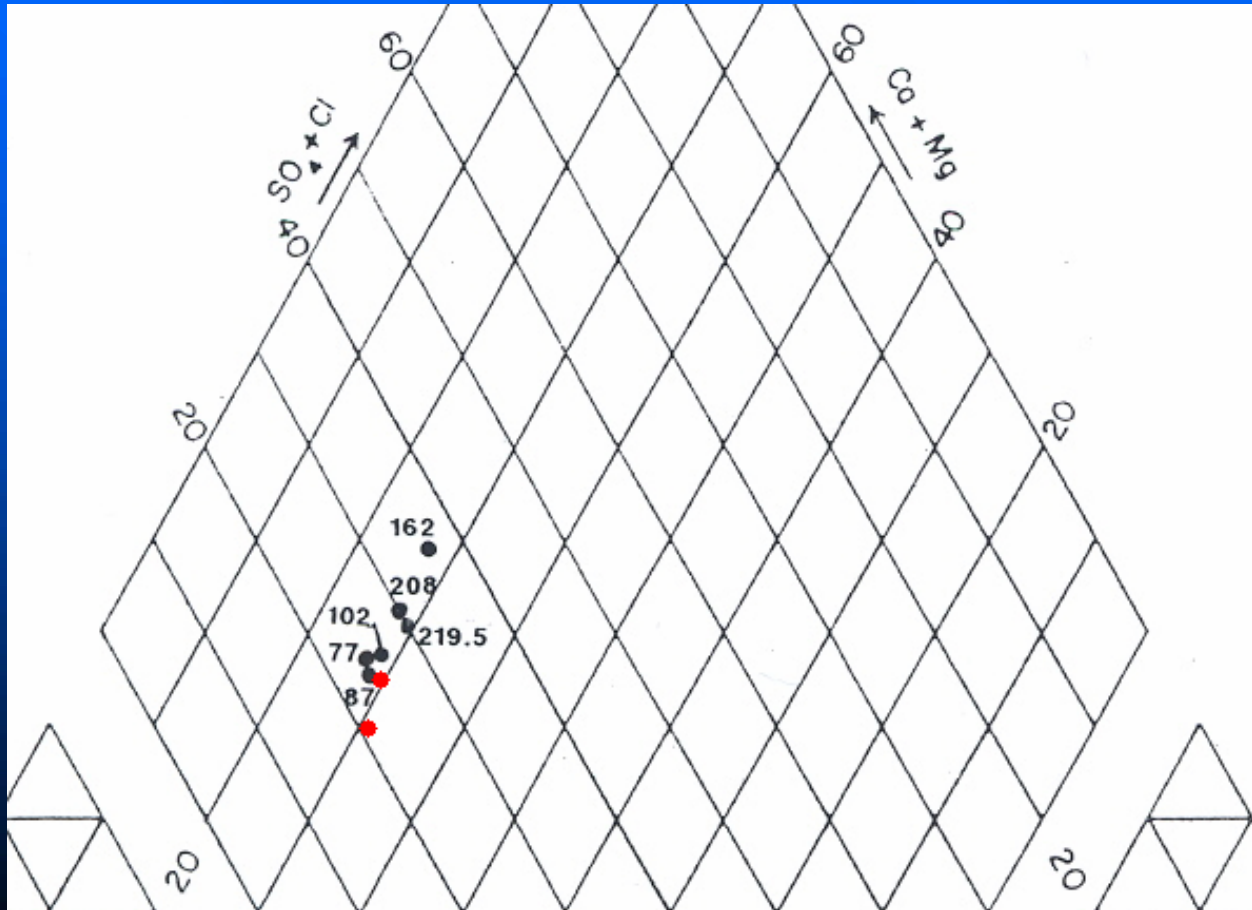
# MW-101 Water Quality

Fracture Depth Ft / Yield (gpm)	MTBE(ug/L)	TBA (ug/L)
77 / 1.5	2,500	<2,000
87 / 0.8	2,800	<4,000
103 / 3.3	3,300	<4,000
152 / 0.08	1,600	<1,000
162 / 3.5	430	<1,000
208 / 2.25	260	4.2
220 / 4.0	820	<1,000

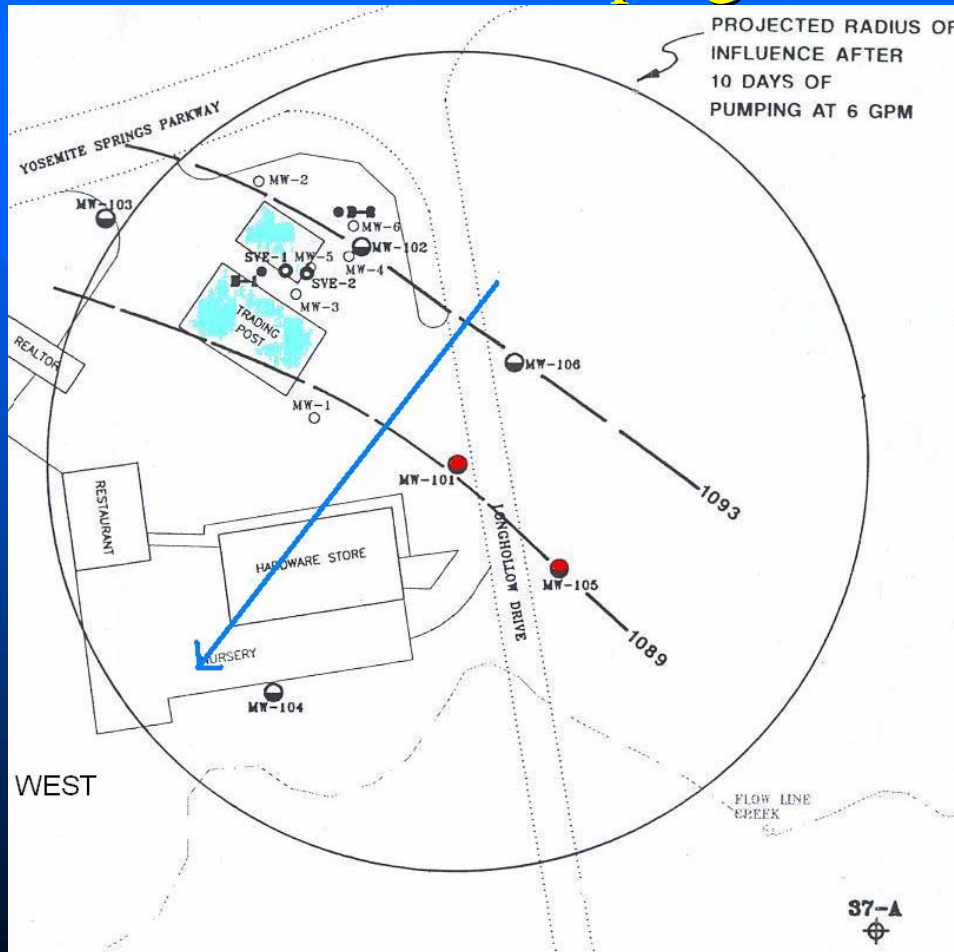
# Radius of Influence – Pumping from MW-101

- MTBE is relatively persistent within the aquifer, degrading slowly to TBA as oxygen is available and likely assisted by leachfield bacteria.
- MW-101 is well connected hydraulically to the MTBE plume from the station, as well as to the fault water supply feeding the impacted water supply wells.
- Groundwater extraction from MW-101 on a continuous basis at a rate of approximately 10 gpm appears feasible and is recommended.
- On site treatment for the produced water should be provided prior to discharge.
